Final Report: Wildcat Mountain Stream Crossing

Sterling Forest Backcountry Trails Program

New York-New Jersey Trail Conference

December 2013

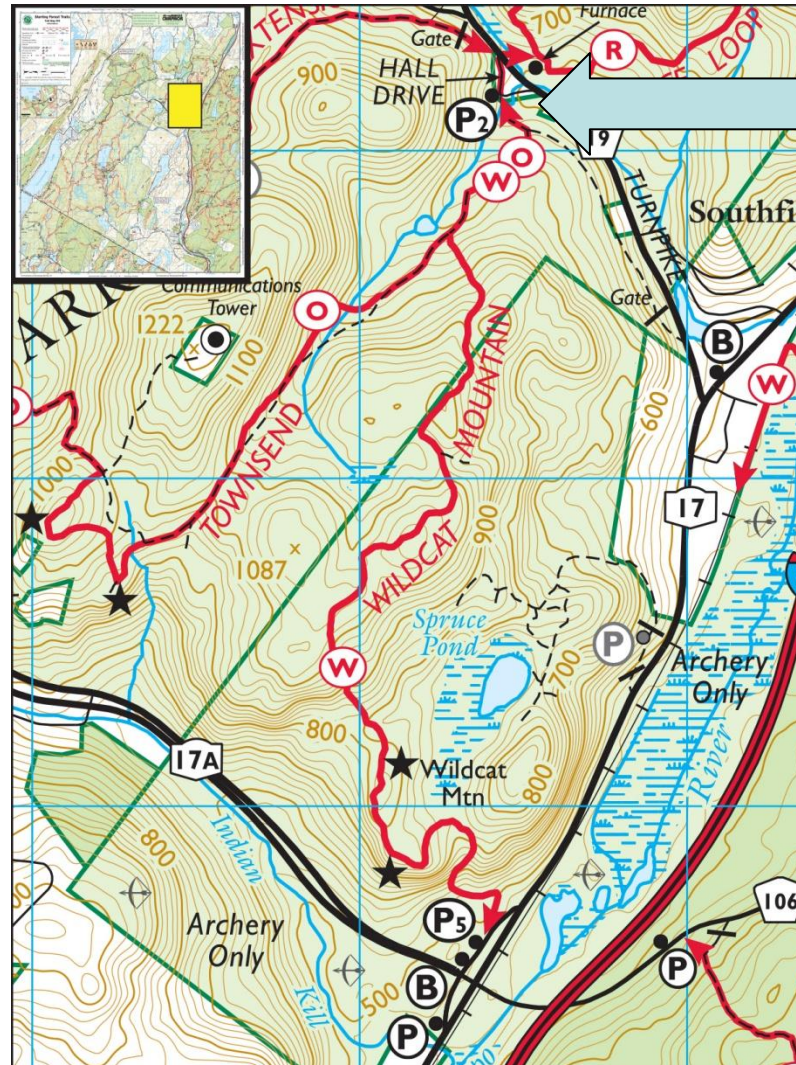
Location of Work site

The stream crossing at the co-aligned Wildcat Mountain-Townsend Trail section had been damaged by several large storm events, requiring more stepping stones to span the stream crossing in addition to a trail section eroded by storms. Armoring of the embankment and trail turnpike sections were required, and an armored drainage ditch to feed upland water away from the trail.

Repair that could resist future storm events was completed, including massive stepping stones in the stream bed and in the deeply eroded trail section; and creation and armoring of a substantial ditch upstream to redirect water flow off-trail while accommodating future siltation

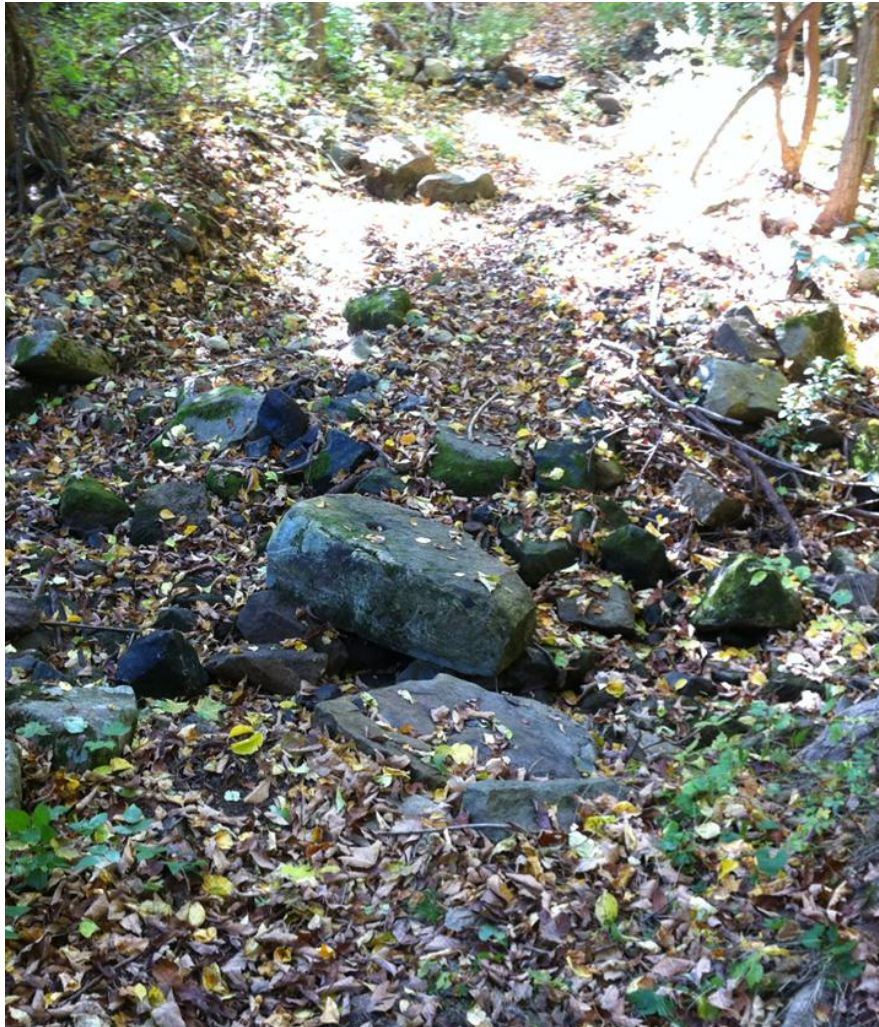
Before

15 Stepping stones placed.

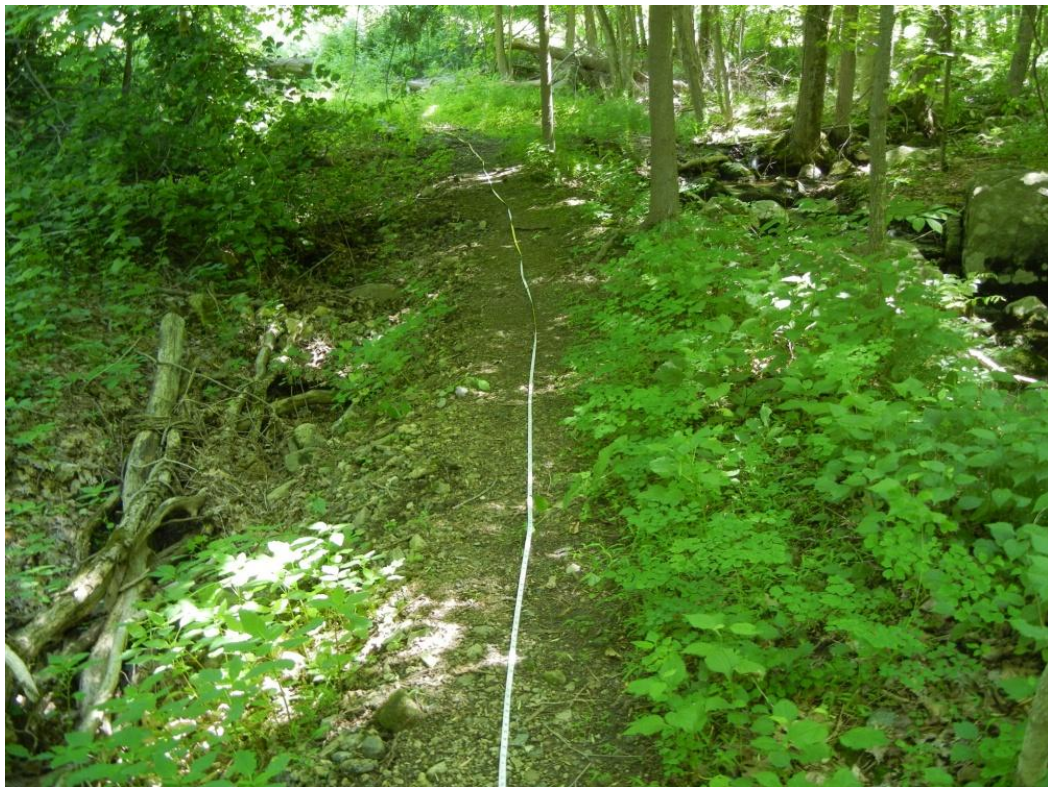
Before

90 linear feet turnpike armored.

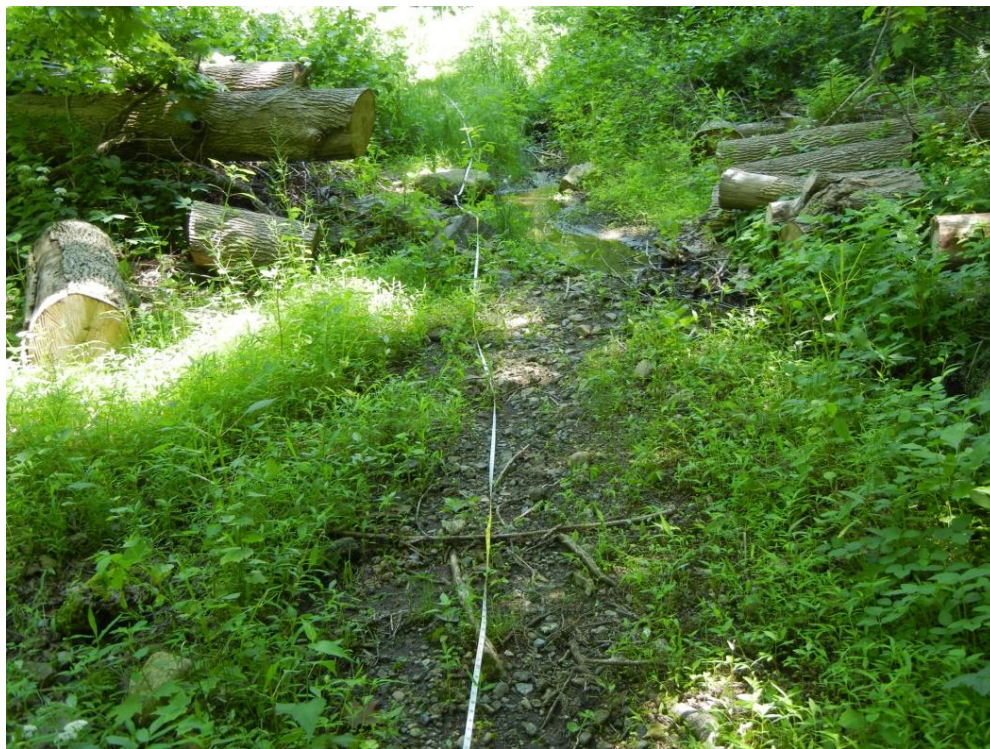
Before

135 linear feet of armored drainage ditch constructed.

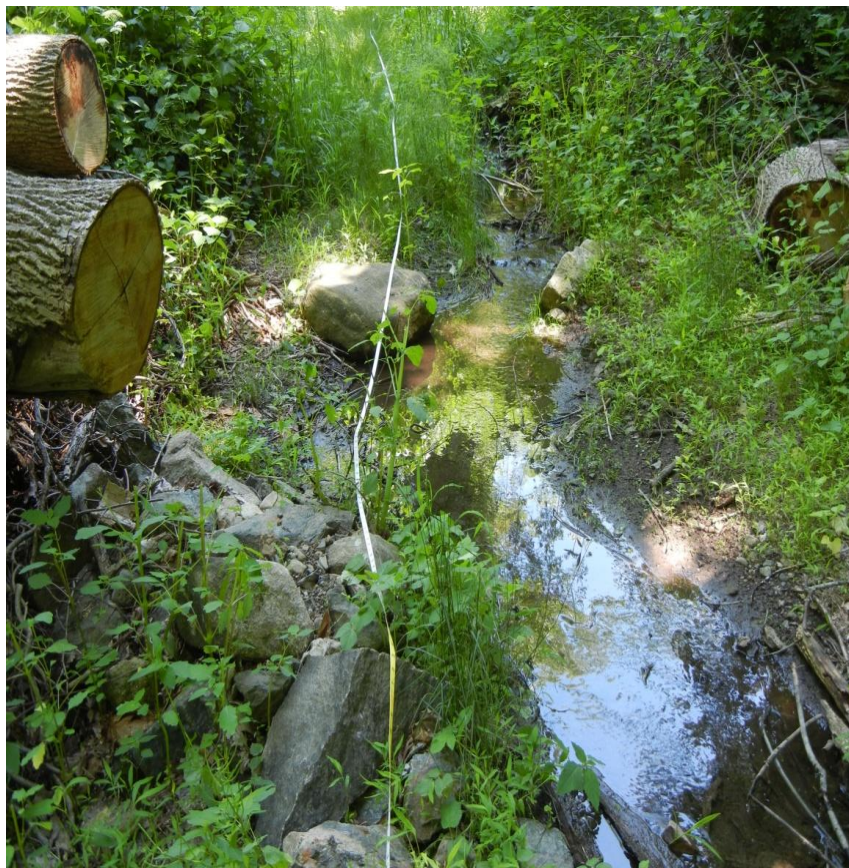
Before

Closer view of ditch and drain.

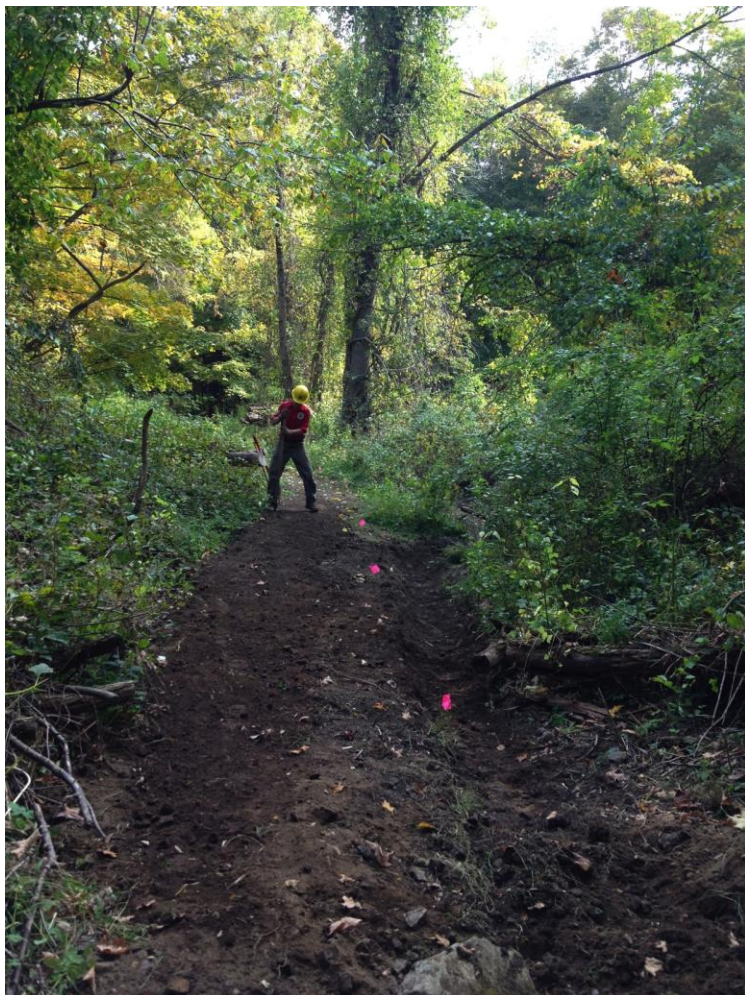
Before

Extended ditch at wet meadow.
